Property and Timber Pest Report

Property Address: 15 Fernlea Street Geebung 4034

Inspection Date: 10 Jul 2024

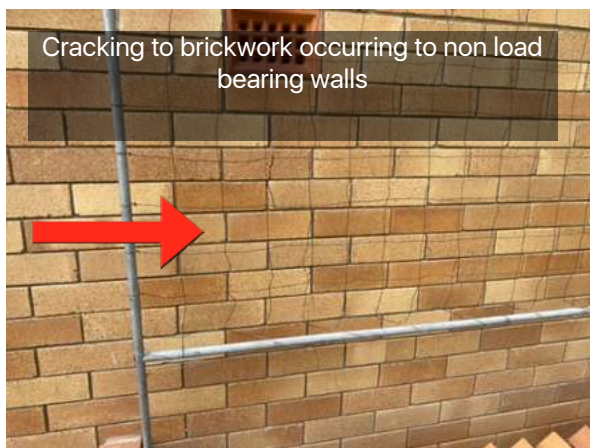
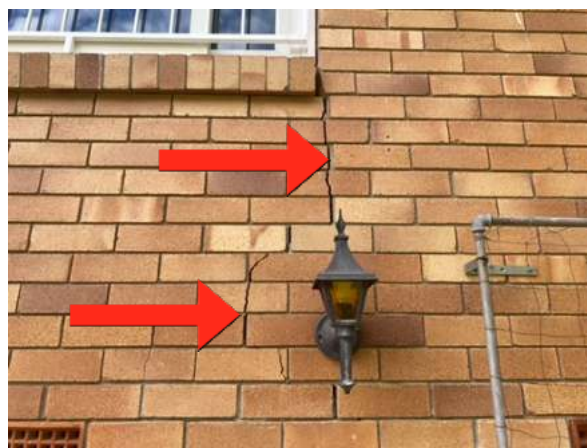
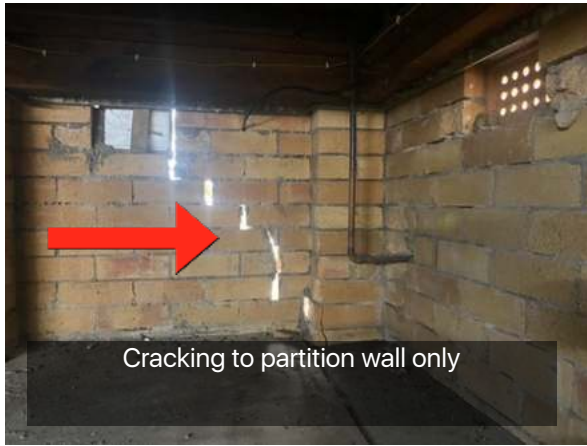
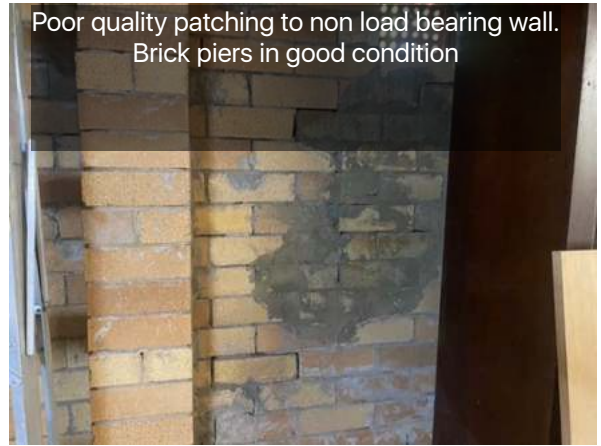
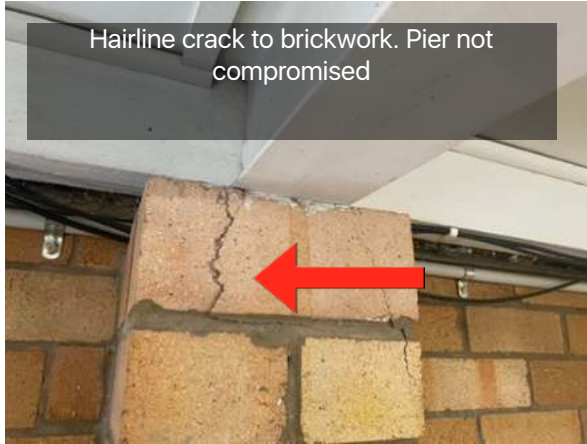
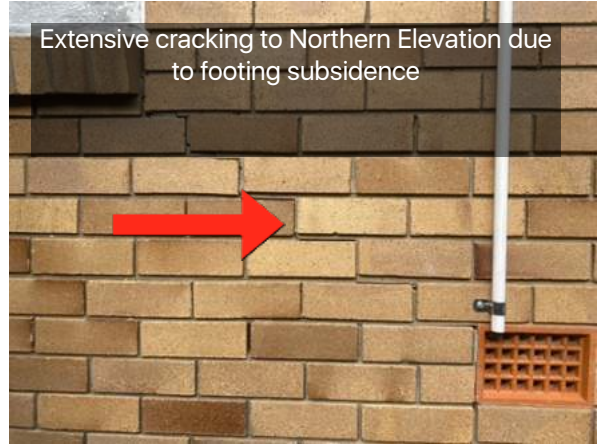
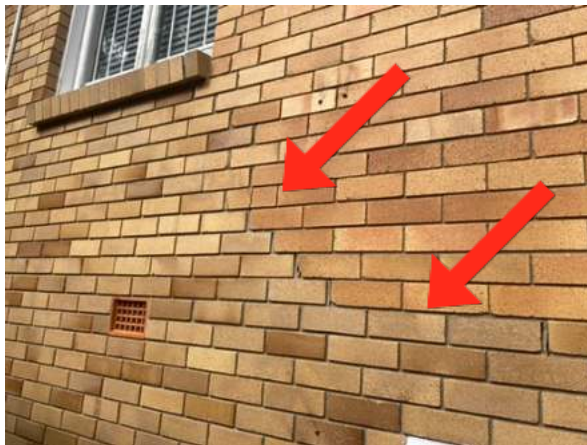
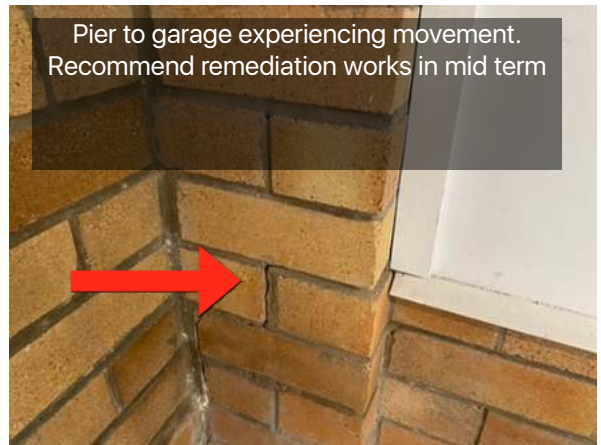
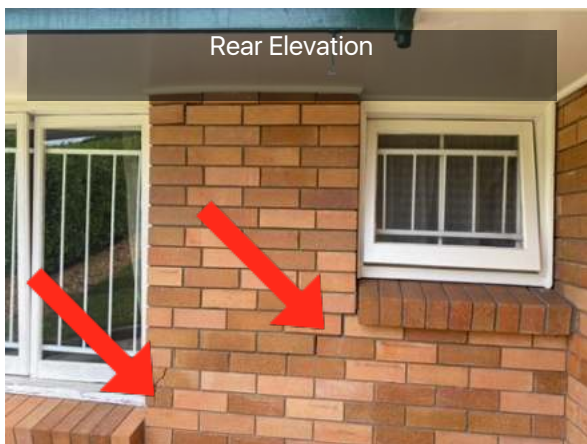
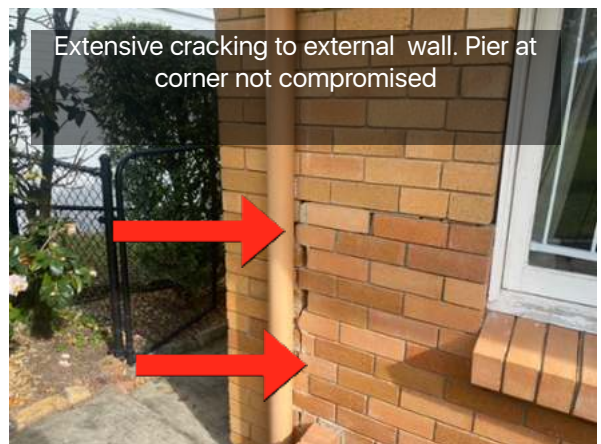
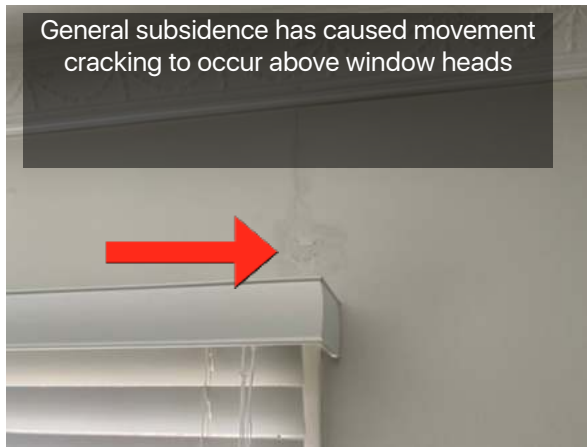
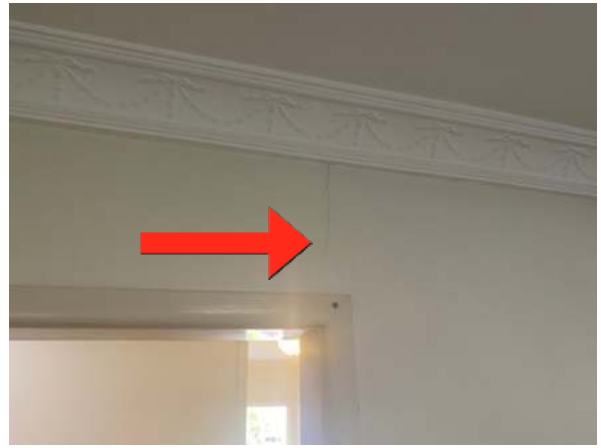
Major Defect 1.01

Finding: Movement cracking

Extensive cracking to brickwork walls to subfloor and rear of dwelling.

Remediation works required where brickwork piers have experienced movement.

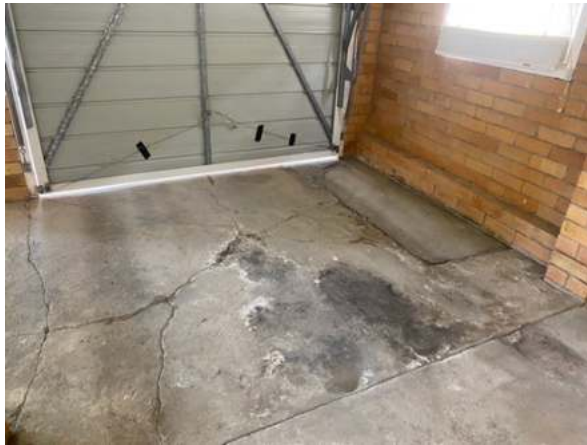
Minor Defect 2.01

Finding: Concrete Hardstand - subsidence

Concrete slab experiencing significant subsidence due to deterioration of sub-grade.

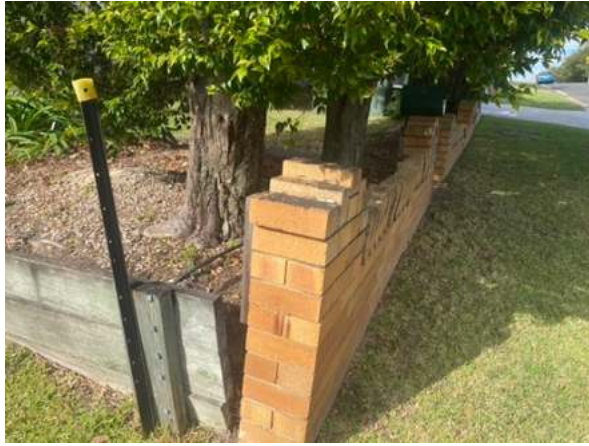
Minor Defect 2.02

Finding: Brickwork retaining wall to boundary

Wall on lean due to tree roots. Satisfactory in current condition

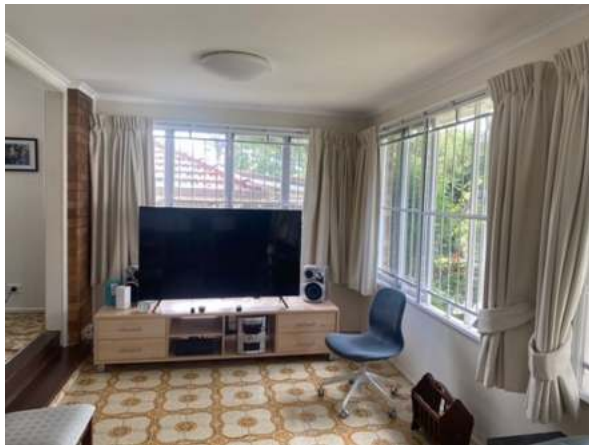
Minor Defect 2.03

Finding: Installation

'Drummy' tiles across length of living area due to a lack of glue to underside of tiles. Take care not to point load surface

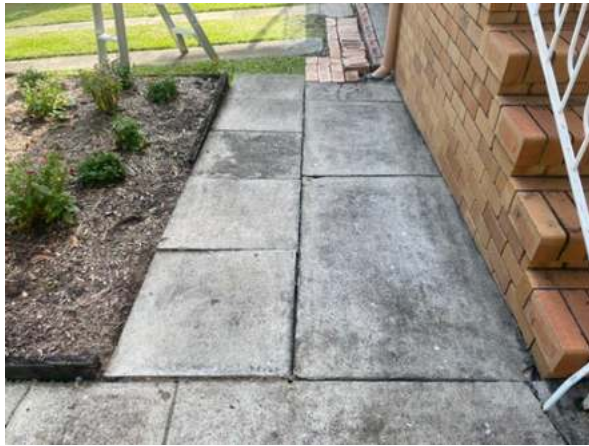
Minor Defect 2.04

Finding: Material Deterioration / Installation

Sub-grade to entry path in poor condition. Large format, loose laid, concrete slabs not level as a result

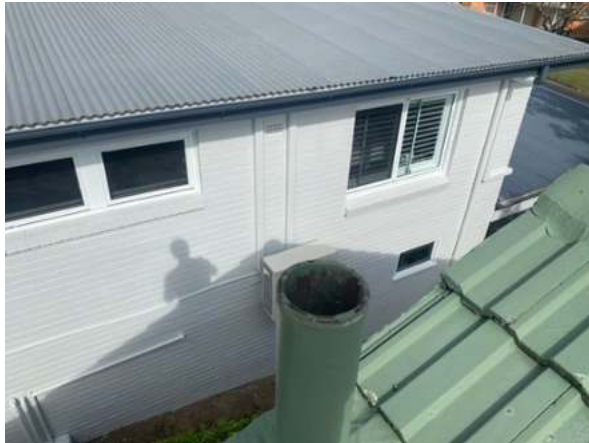
Minor Defect 2.05

Location: Roof exterior
Finding: Installation
Vent pipe not fitted with cover.

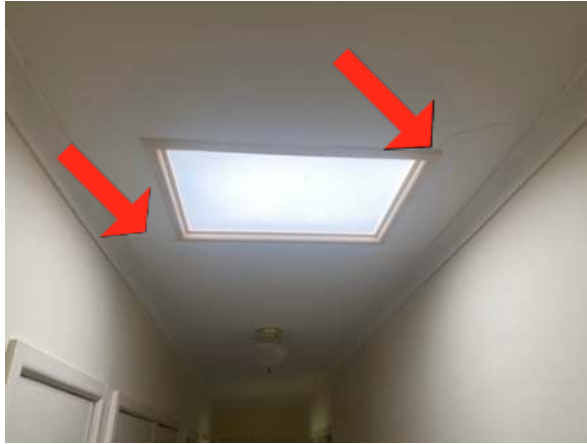
Minor Defect 2.06

Location: Hallway
Finding: Ceiling - Movement - Hairline cracking to ceiling
General movement cracking present to ceiling. Typical for age of dwelling. No moisture detected at time of inspection. Recommend installation of expansion joint to prevent further cracking

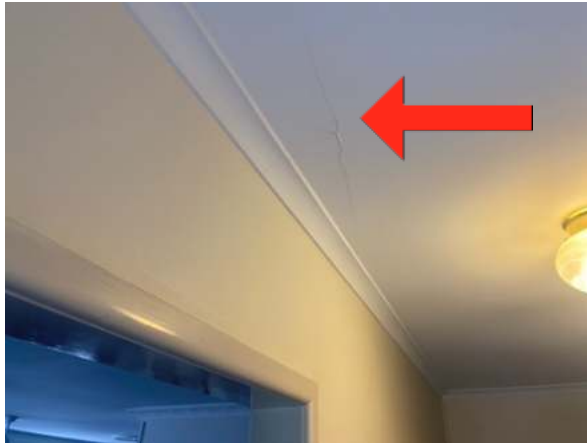
Minor Defect 2.07

Location: Lounge room
Finding: Hairline cracking
No moisture detected

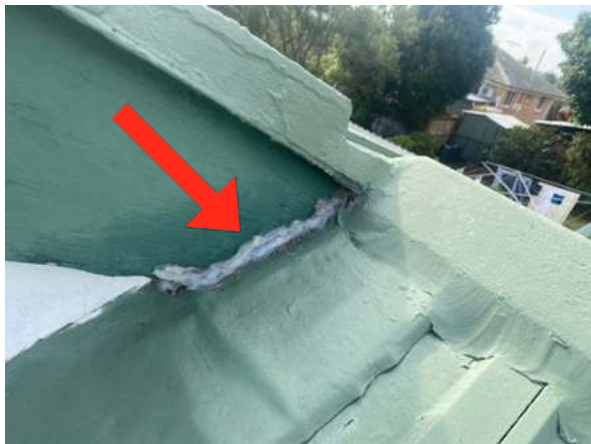
Location: Roof exterior
Finding: Installation

Remediation works undertaken to parapet wall are satisfactory. No moisture readings obtained to interior

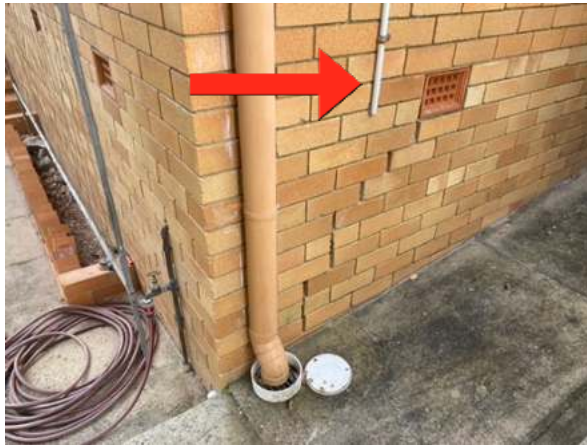
Conditions conducive to timber pest attack 4.01

Finding: Installation

Recommend extending condensation lines to drain into stormwater

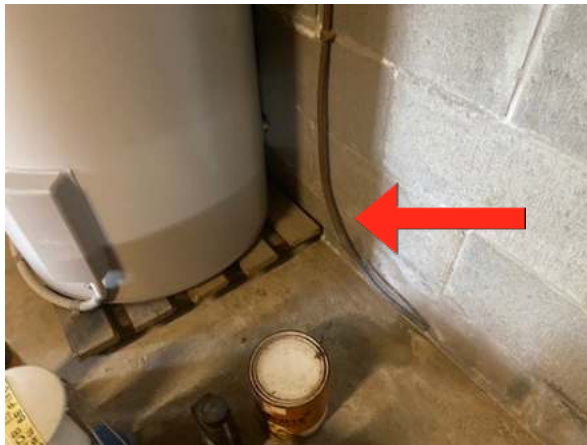
Conditions conducive to timber pest attack 4.02

Location: Garage
Finding: Installation
Overflow to hot water unit to be extended to vent into suitable drainage outlet

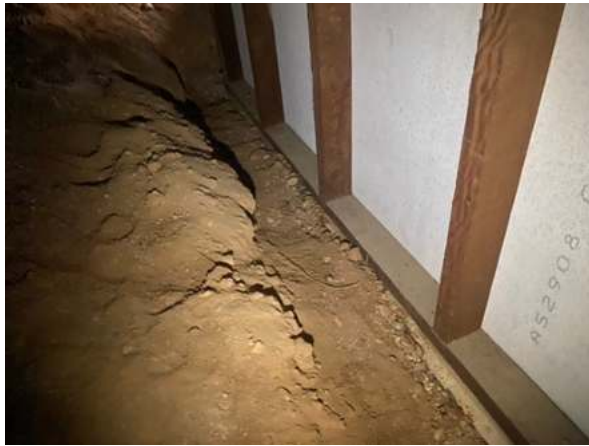
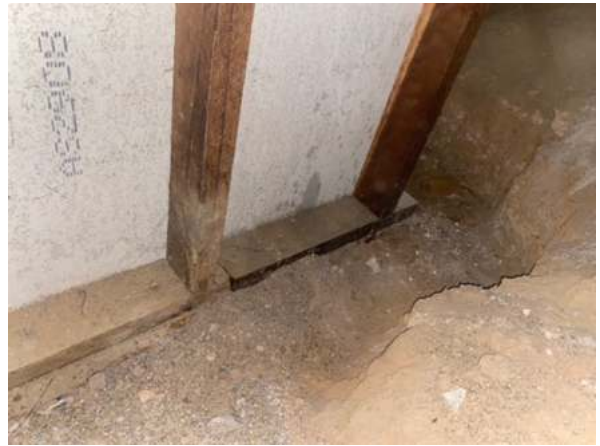
Conditions conducive to timber pest attack 4.04

Location: Subfloor
Finding: Visual inspection compromised
Recommend removal of soil in direct contact with timber base plate of wall framing

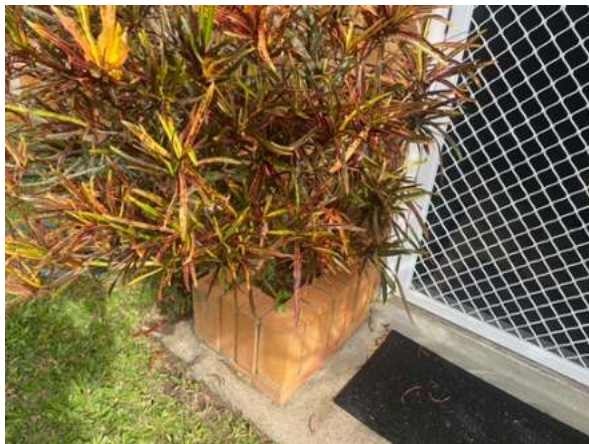
Conditions conducive to timber pest attack 4.05

Finding: Built in planter

Planting in direct contact with dwelling is conducive to termite activity, visual inspection barrier is also compromised. Recommend removal of planting
